ARMOR-HARD JOINT REBUILD SEQUENCE

METZGER/McGUIRE

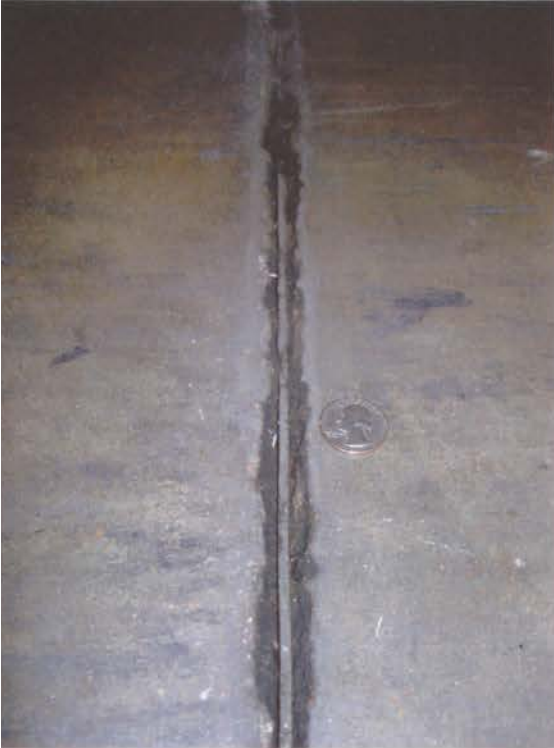
EXISTING CONDITION

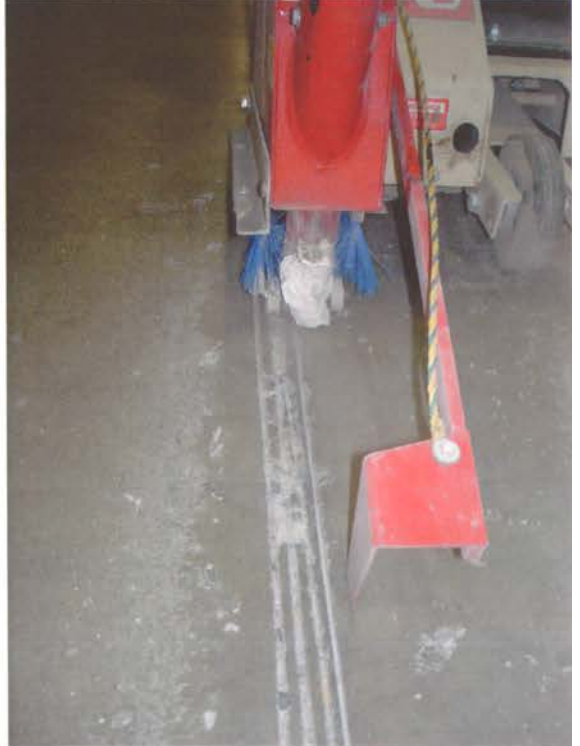
SAW CUT LINES BEHIND SPALL

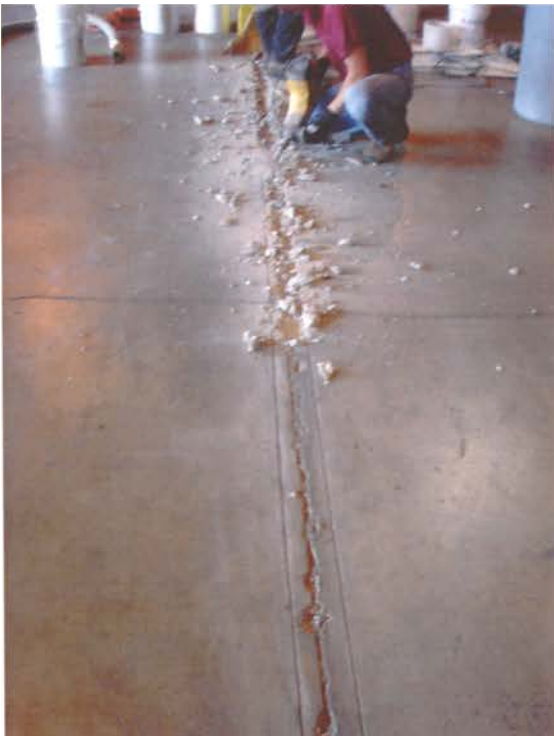
REMOVE REMAINING CONCRETE

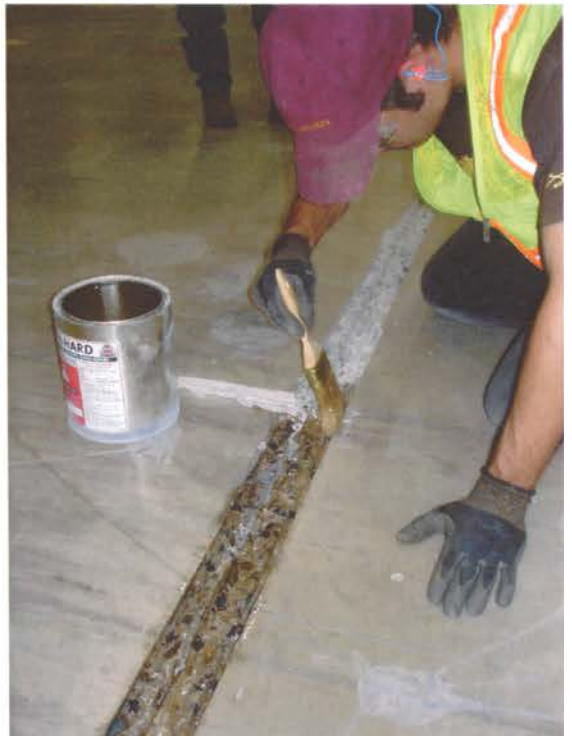
PRIME CLEANED JOINT WITH AH LIQUID

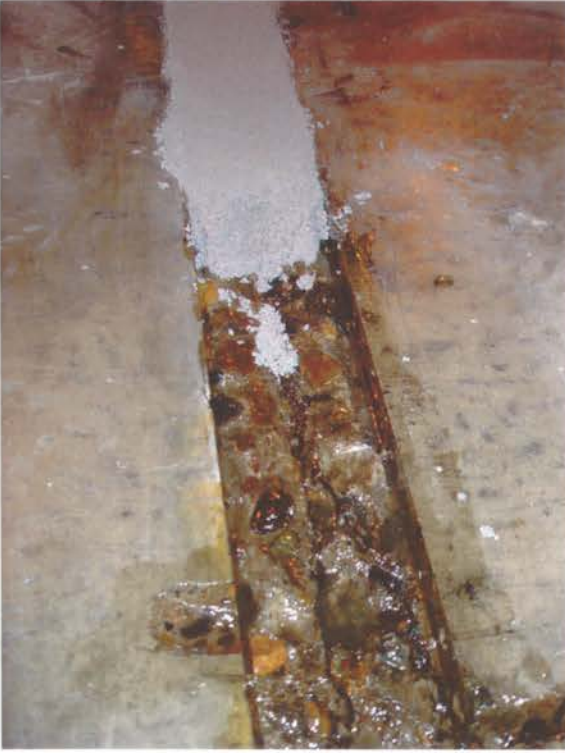
FILL JOINT WITH ARMOR-HARD MORTAR

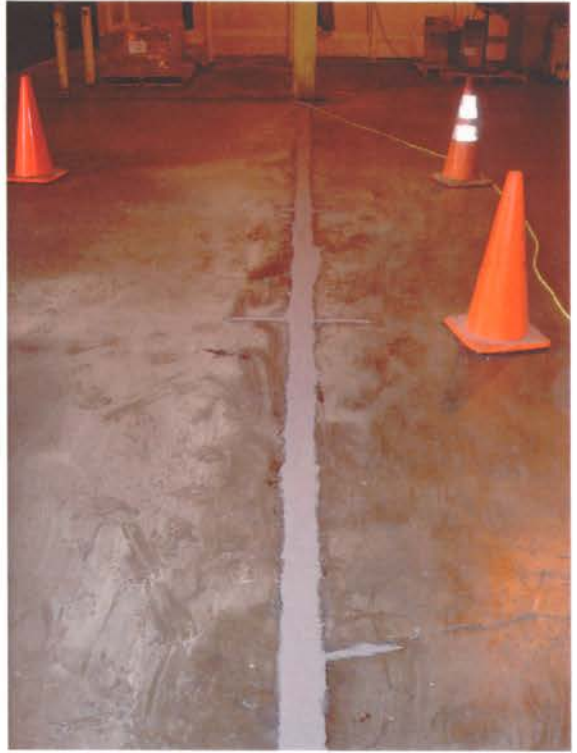
TROWEL FLUSH WITH FLOOR

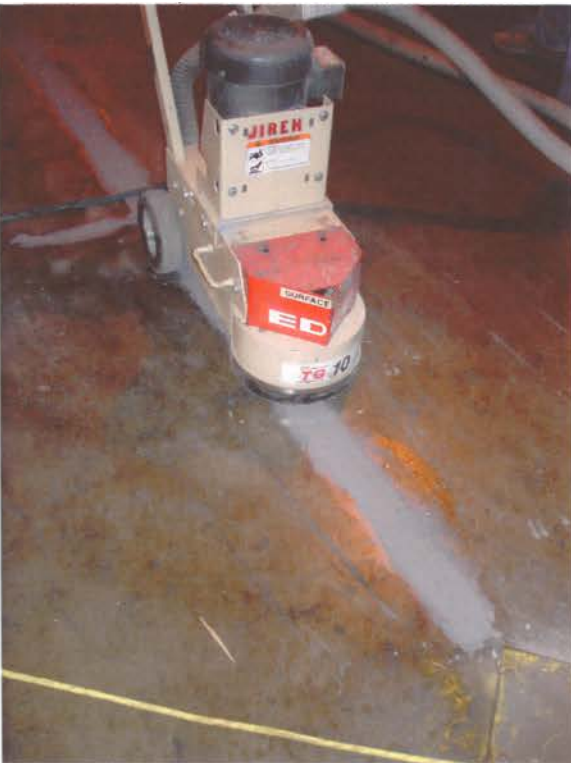
AFTER CURE, GRIND FLUSH WITH SURFACE

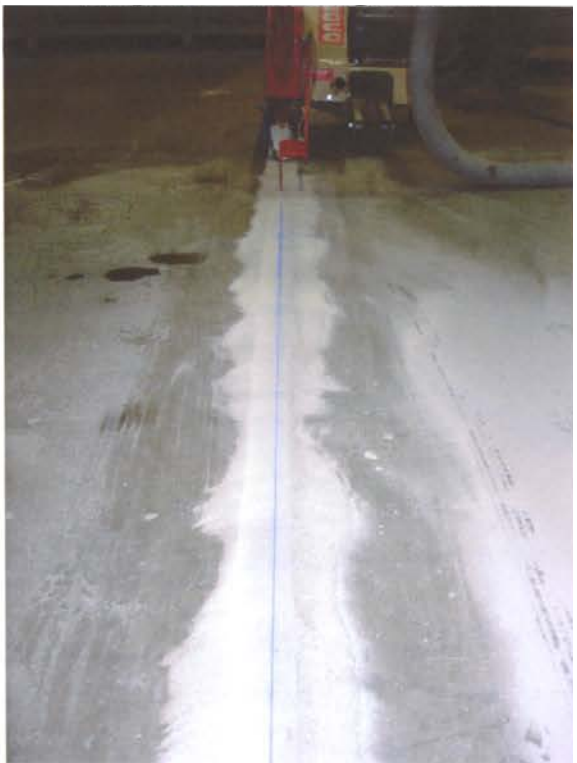
SNAP LINE OVER ORIGINAL JOINT

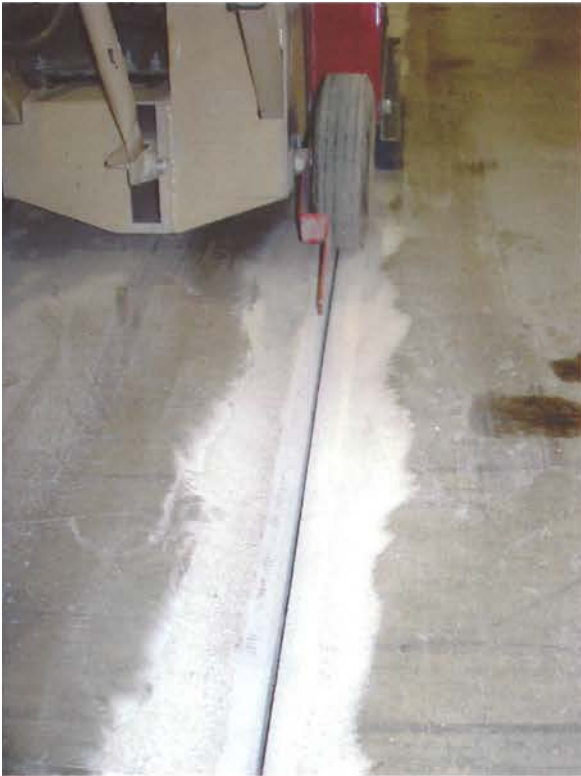
SAW CUT NEW JOINT

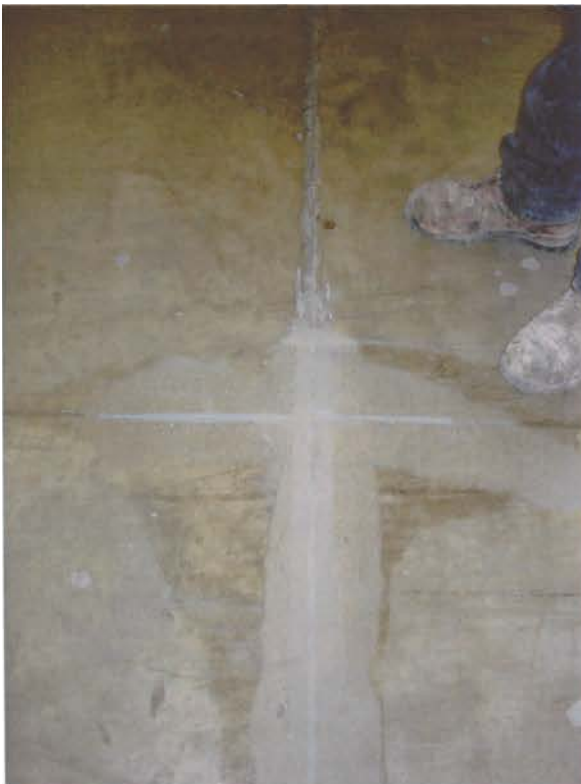
**RAZOR OFF CURED
SPAL-PRO 2000 OVERFILL**

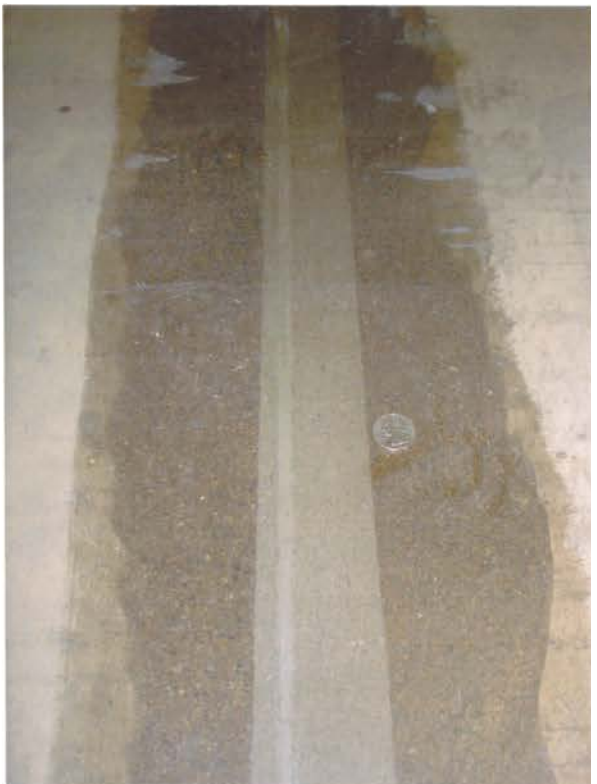
FINISHED CONDITION
